# DEFECT REPORT - OUTSTANDING

## Sample Defect Report - 29 June 2026

Sample Client  
123 Sample Street, Melbourne

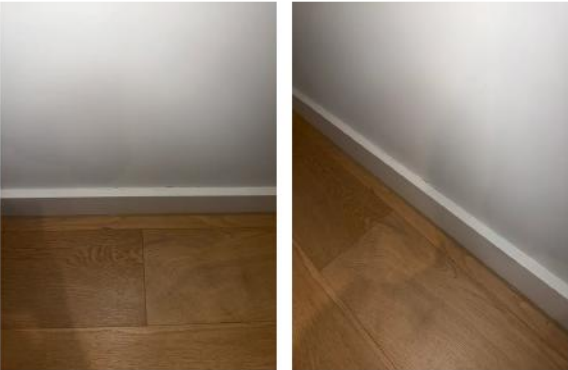
| Number | DEF-001 |

| Issue | There is a crack in between the wall and the Architrave. |
| Details | There is a crack in between the wall and the Architrave. |
| Priority | <span>🔼</span> Medium |

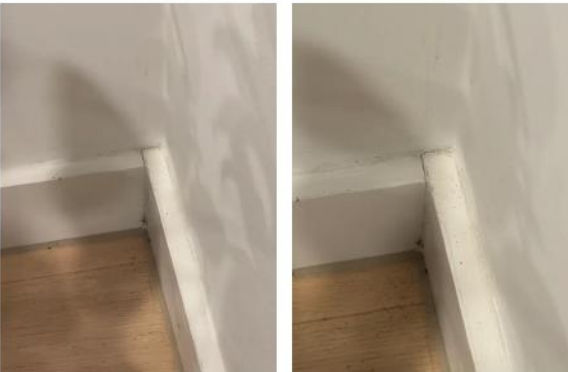
| Number | DEF-002 |

| Issue | Crack |
| Details | Cracking at join where 2 architraves meet. |
| Priority | <span>↑</span> Medium |

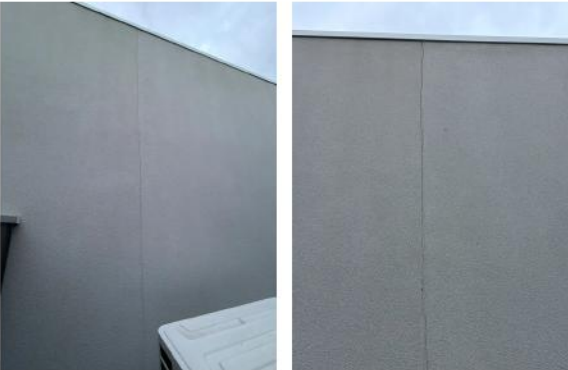
| Number | DEF-003 |

| Issue | Cracking along render joint, large cracking towards the top, smaller cracking towards the bottom completely through the top and the bottom of the render. |
| Priority | <span>↑</span> Medium |

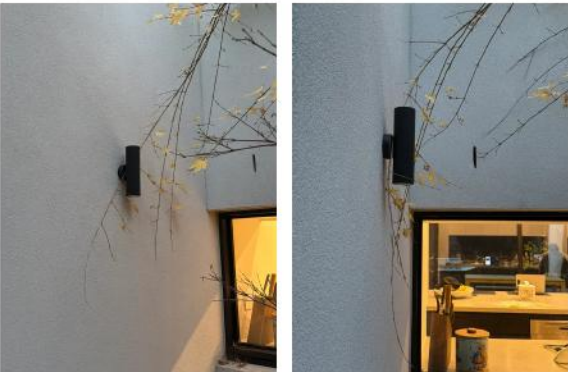
| Number | DEF-004 |

| Issue | Electrical fault |
| Details | When light is turned on for more than 10 seconds, house power goes out (shorts whole house). |
| Priority | <span>↑</span> High |

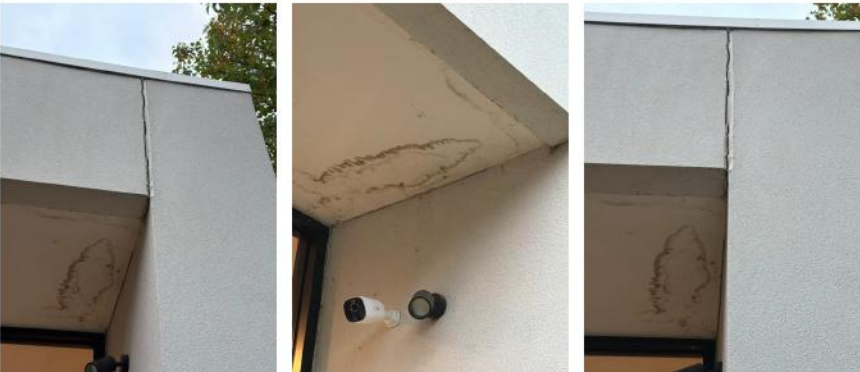
| Number | DEF-005 |

| Issue | Brenda is cracked separating from wall and roof awning |
| Details | Brenda is cracked separating from wall and roof awning. It is fully separated from the right side of the wall as the crack follows the whole way top down to underneath from where the plaster roof is connected to the side of the render under the awning |
| Priority | <span>🔴</span> High |

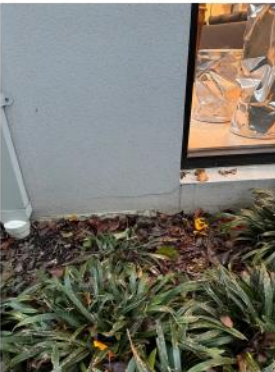
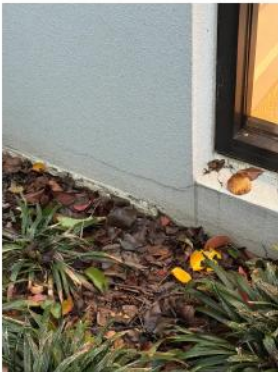
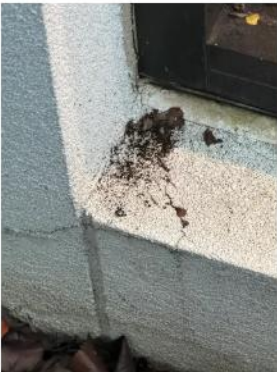
| Number | DEF-006 |

| Issue | Cracking on base of windowsill at far back of house behind lounge room. |
| Priority | <span>↑</span> Medium |

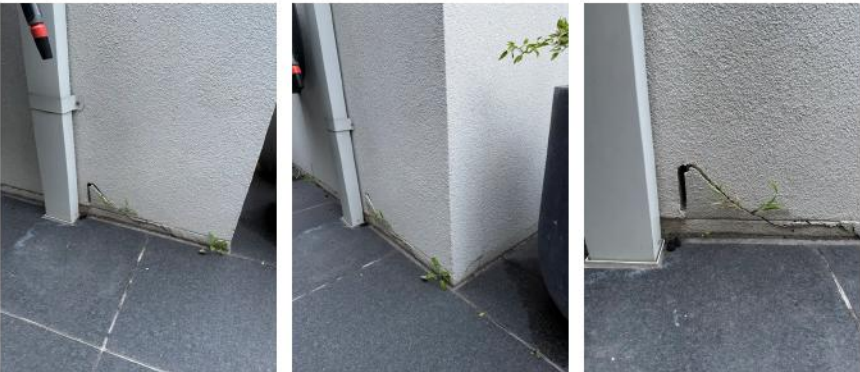
| Number | DEF-007 |

| Issue | Very large crack towards breathing holes where render is |
| Details | Very large crack towards breathing holes where render is. Render is coming off the wall and lower down the render is crumbling with smaller fracture cracks underneath the large crack. |
| Priority | <span>🔴</span> High |

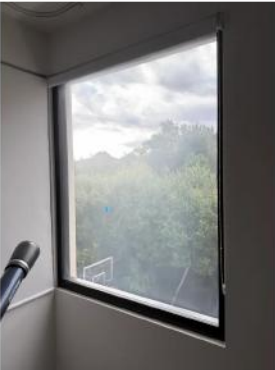
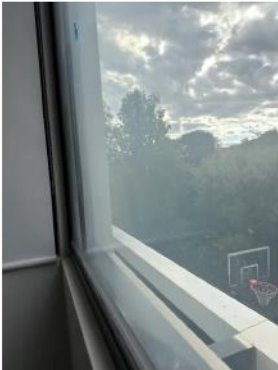
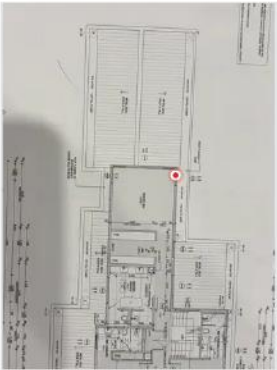
| Number | DEF-008 |

| Issue | Master bedroom back right window is permanently fogged/hazed |
| Details | Master bedroom back right window is permanently fogged/hazed. Needs to be inspected and replaced.<br>Note: Previously all windows were buffed upstairs, but this one was missed in that process. |
| Priority | <span>🔼</span> Medium |

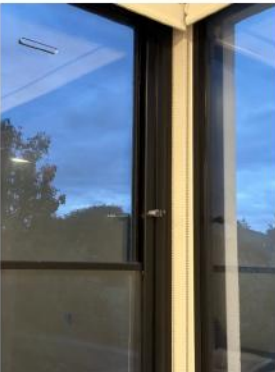
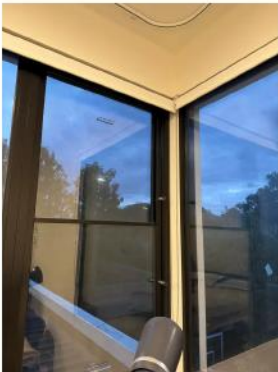
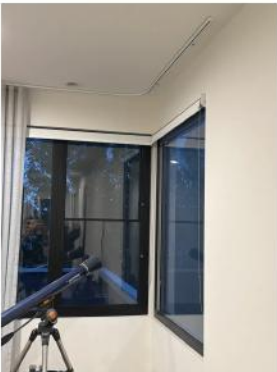
| Number | DEF-009 |

| Issue | Seems to be missing spring on top window locking mechanism. |
| Priority | <span>↑</span> Medium |

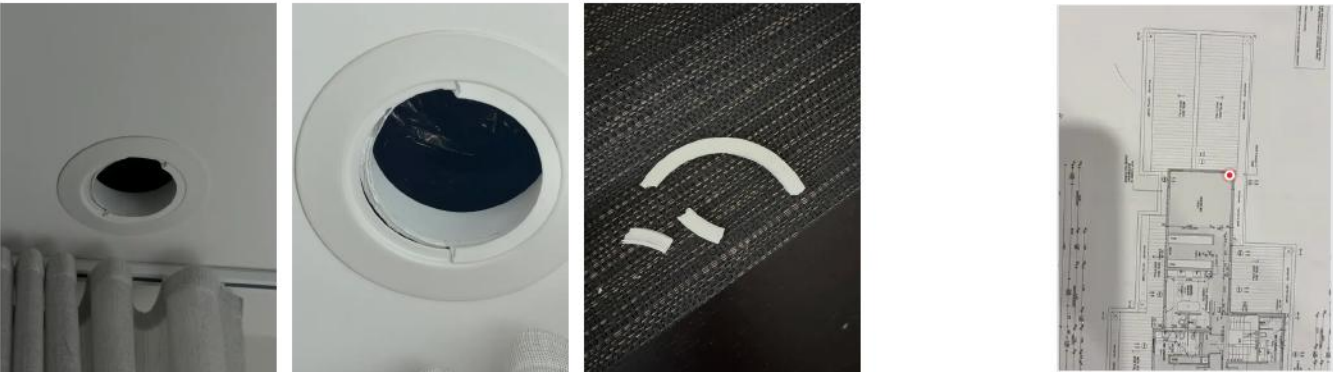
| Number | DEF-010 |

| Issue | Inner lip trim has cracked and broken off |
| Details | Inner lip trim has cracked and broken off. Need replacement and installation. |
| Priority | <span>↑</span> Medium |

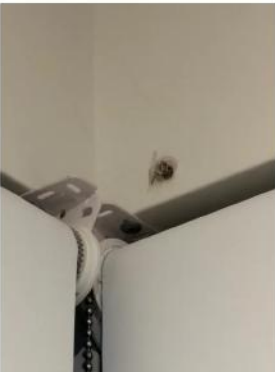
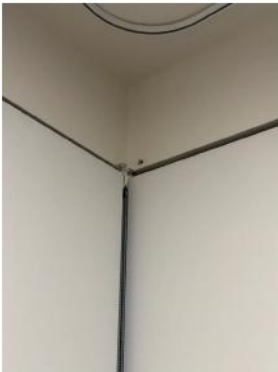
| Number | DEF-011 |

| Issue | Random screw left in master bedroom above window |
| Details | Random screw left in master bedroom above window. Needs removal and patching/painting |
| Priority | <span>↑</span> Medium |

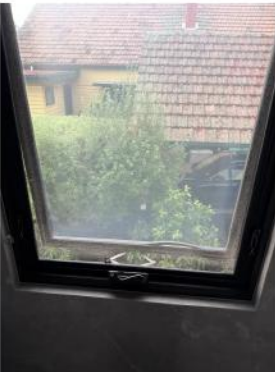
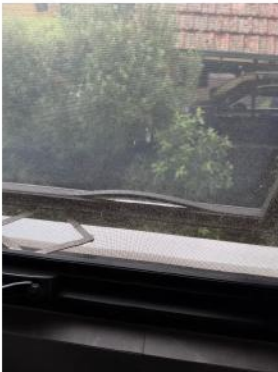
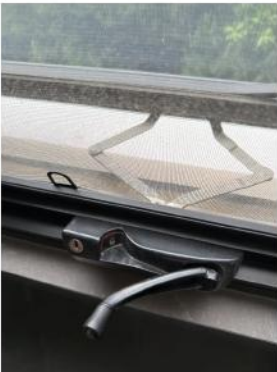
| Number | DEF-012 |

| Issue | Rubber/foam steel is warped/peeling up |
| Details | Rubber/foam steel is warped/peeling up. In bedroom 3 ensuite bathroom window. |
| Priority | <span>↑</span> Medium |

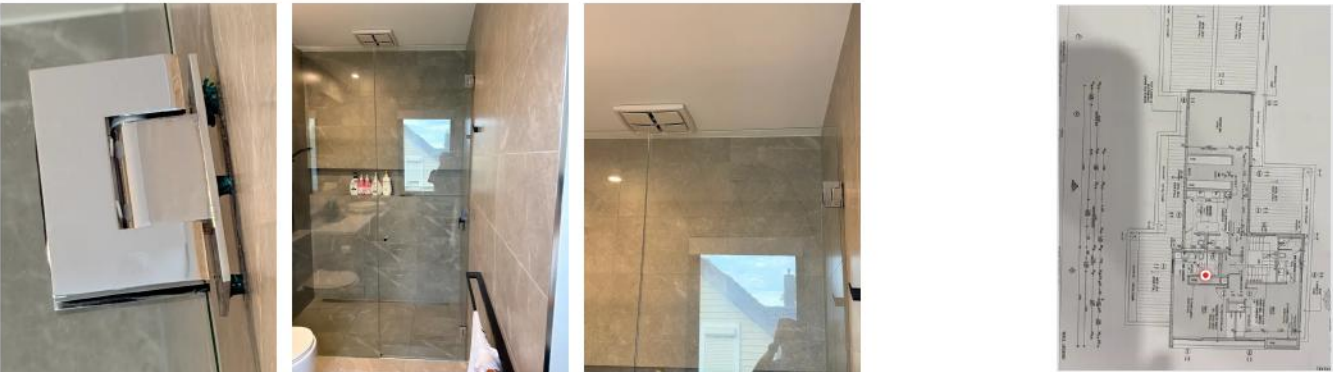
| Number | DEF-013 |

| Issue | Top shower hinge has come out of the wall about 1 cm |
| Details | Top shower hinge has come out of the wall about 1 cm. Putting pressure on lower hinge and tile. Both hinge and tile should be checked. |
| Priority | <span>🔼</span> Medium |
