# DEFECT REPORT - OUTSTANDING

## Sample Defect Report - 29 June 2026

Sample Client  
123 Sample Street, Melbourne

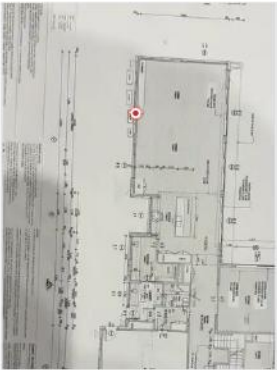
| Number | DEF-001 |

| Issue | There is a crack in between the wall and the Architrave. |
| Details | There is a crack in between the wall and the Architrave. |

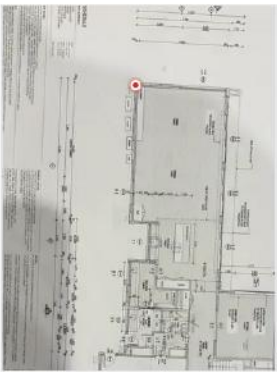
| Number | DEF-002 |

| Issue | Crack |
| Details | Cracking at join where 2 architraves meet. |

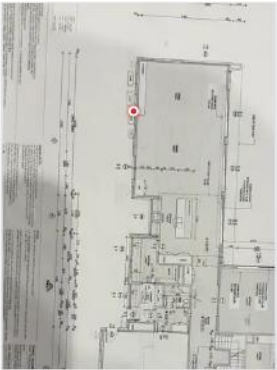
| Number | DEF-003 |

| Issue | Cracking along render joint, large cracking towards the top, smaller cracking towards the bottom completely through the top and the bottom of the render. |
| Details | Cracking along render joint, large cracking towards the top, smaller cracking towards the bottom completely through the top and the bottom of the render. |

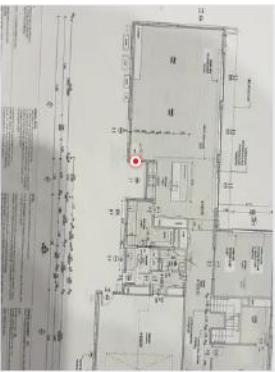
| Number | DEF-004 |

| Issue | Electrical fault |
| Details | When light is turned on for more than 10 seconds, house power goes out (shorts whole house). |

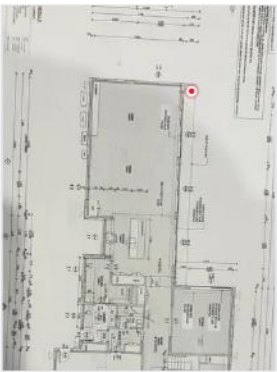
| Number | DEF-005 |

| Issue | Brenda is cracked separating from wall and roof awning |
| Details | Brenda is cracked separating from wall and roof awning. It is fully separated from the right side of the wall as the crack follows the whole way top down to underneath from where the plaster roof is connected to the side of the render under the awning |

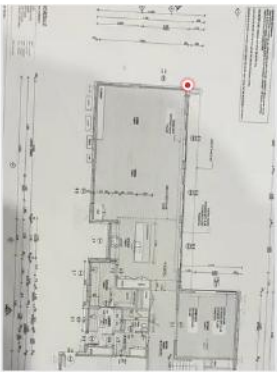
| Number | DEF-006 |

| Issue | Cracking on base of windowsill at far back of house behind lounge room. |
| Details | Cracking on base of windowsill at far back of house behind lounge room. |

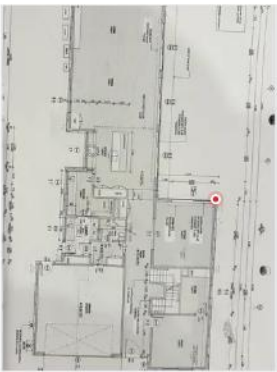
| Number | DEF-007 |

| Issue | Very large crack towards breathing holes where render is |
| Details | Very large crack towards breathing holes where render is. Render is coming off the wall and lower down the render is crumbling with smaller fracture cracks underneath the large crack. |

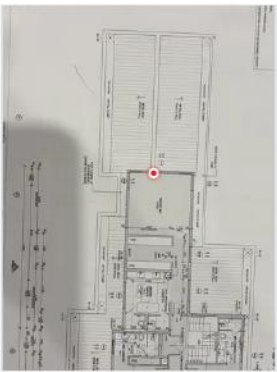
| Number | DEF-009 |

| Issue | Seems to be missing spring on top window locking mechanism. |
| Details | Seems to be missing spring on top window locking mechanism. |
